Deer Creek: A Stage 0 Approach to River Restoration

Background

Design

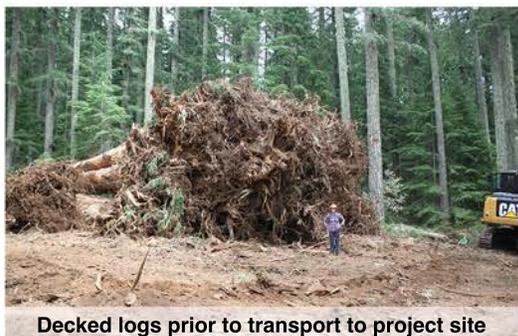
Decked logs prior to transport to project site

The first step of the Project was to divert sections of Deer Creek so that berm removal, channel fill, and large wood placement could take place in dry conditions. A bulldozer and large excavator were used to construct small dams on Deer Creek, temporarily diverting stream flow into side channels. Small teams collected stranded fish from the dewatered channel and relocated them outside of the project area. Streamside berms were then removed and the material placed within incised portions of Deer Creek. Over 450 pieces of large wood were then distributed throughout the project area in various-sized log jams. The diversion dams were then removed allowing the creek to flow freely over the newly reconnected valley bottom and around the placed log jams, forming complex pools and braided channels.

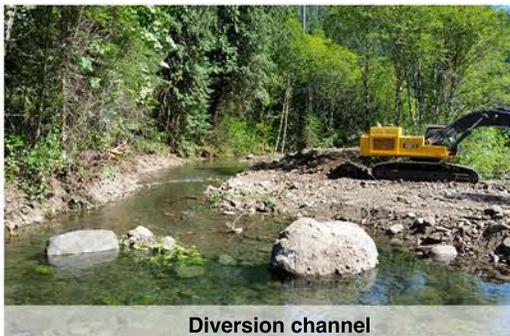
Diversion channel

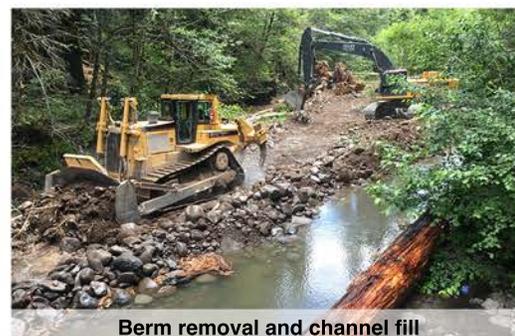
Berm removal and channel fill

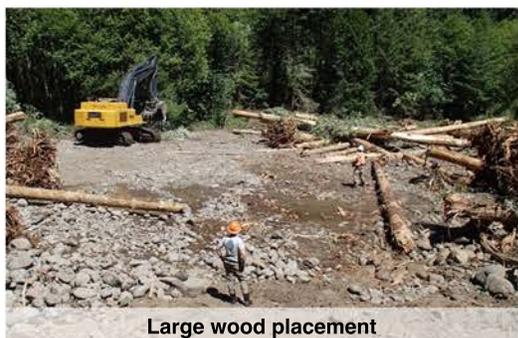
Large wood placement

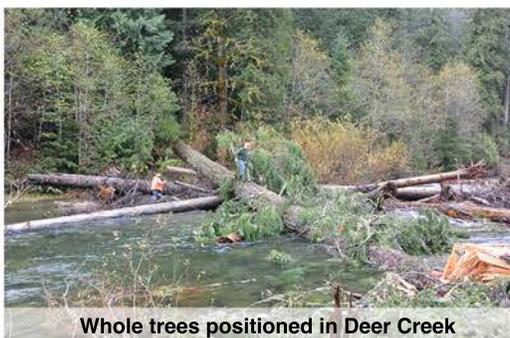
Whole trees positioned in Deer Creek

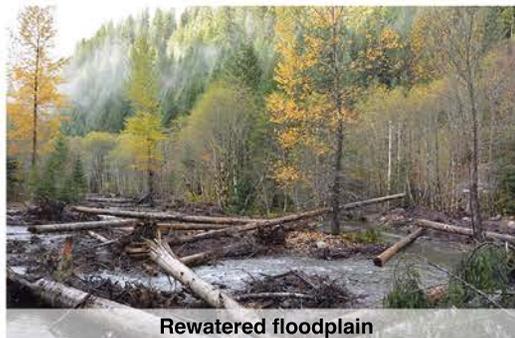
Rewatered floodplain

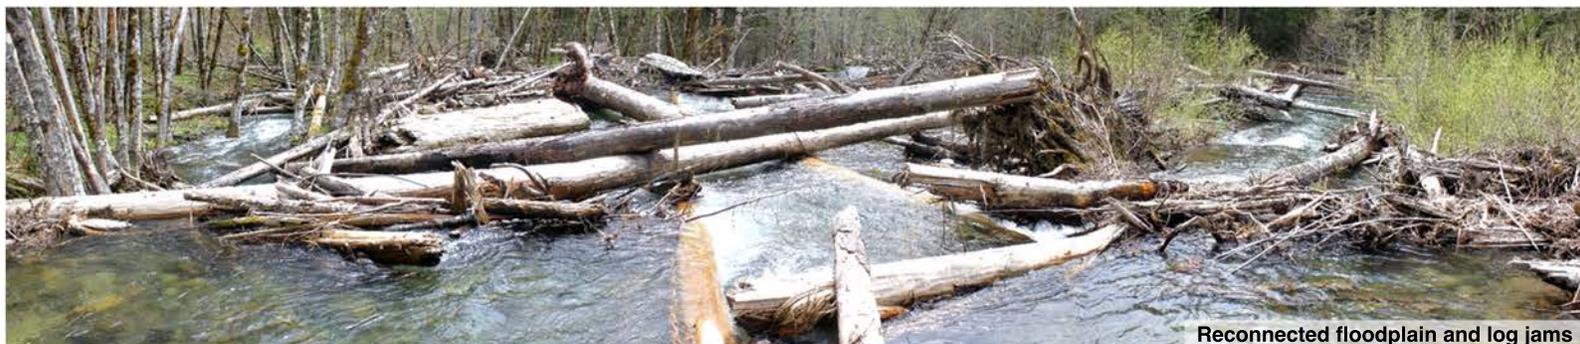
Reconnected floodplain and log jams

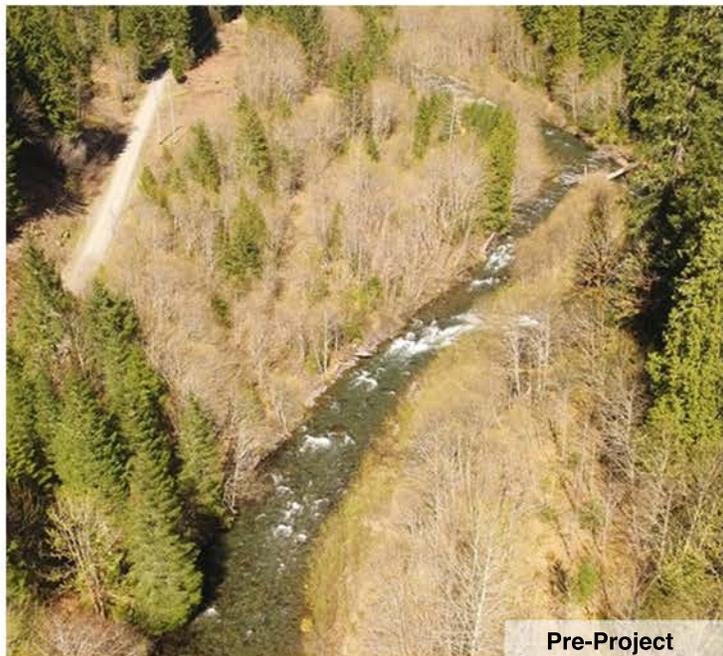
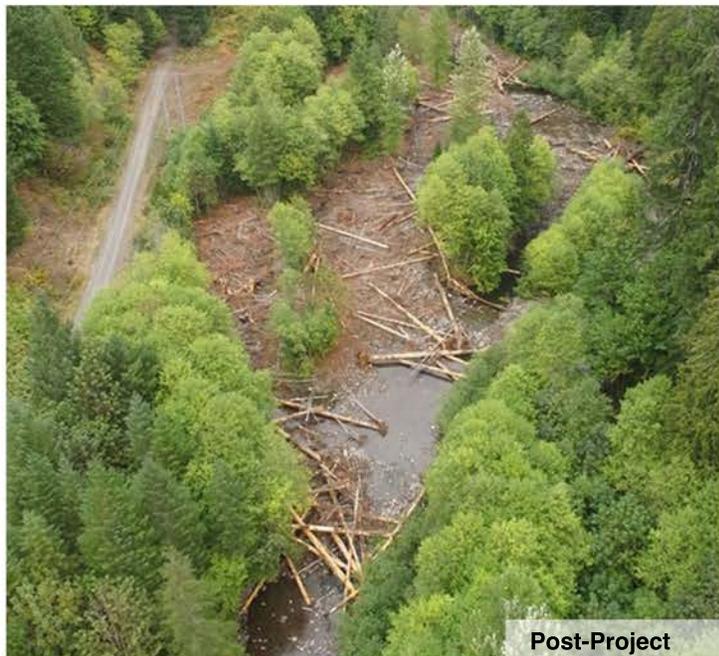
Early results of the restoration are encouraging. Deer Creek changed from less than 30 pieces of large wood per mile to over 300. The previously constrained channel now connects to its valley bottom. Pre- and post-project photos show a dramatic difference in how the creek meanders through the valley bottom. Water flowing downstream is now slowed and redirected by complex log jams and islands, creating a diversity of habitats. As water flows over logs and a wider channel, it slows down allowing gravels to deposit and accumulate, creating spawning habitat. Before, a narrower channel with fast-flowing water would have carried those gravels downstream.
